# CAN WE LEARN FROM PAST INCIDENTS

Paul Markham

London Power Forum, The Altitude, London, 13 Nov 2014

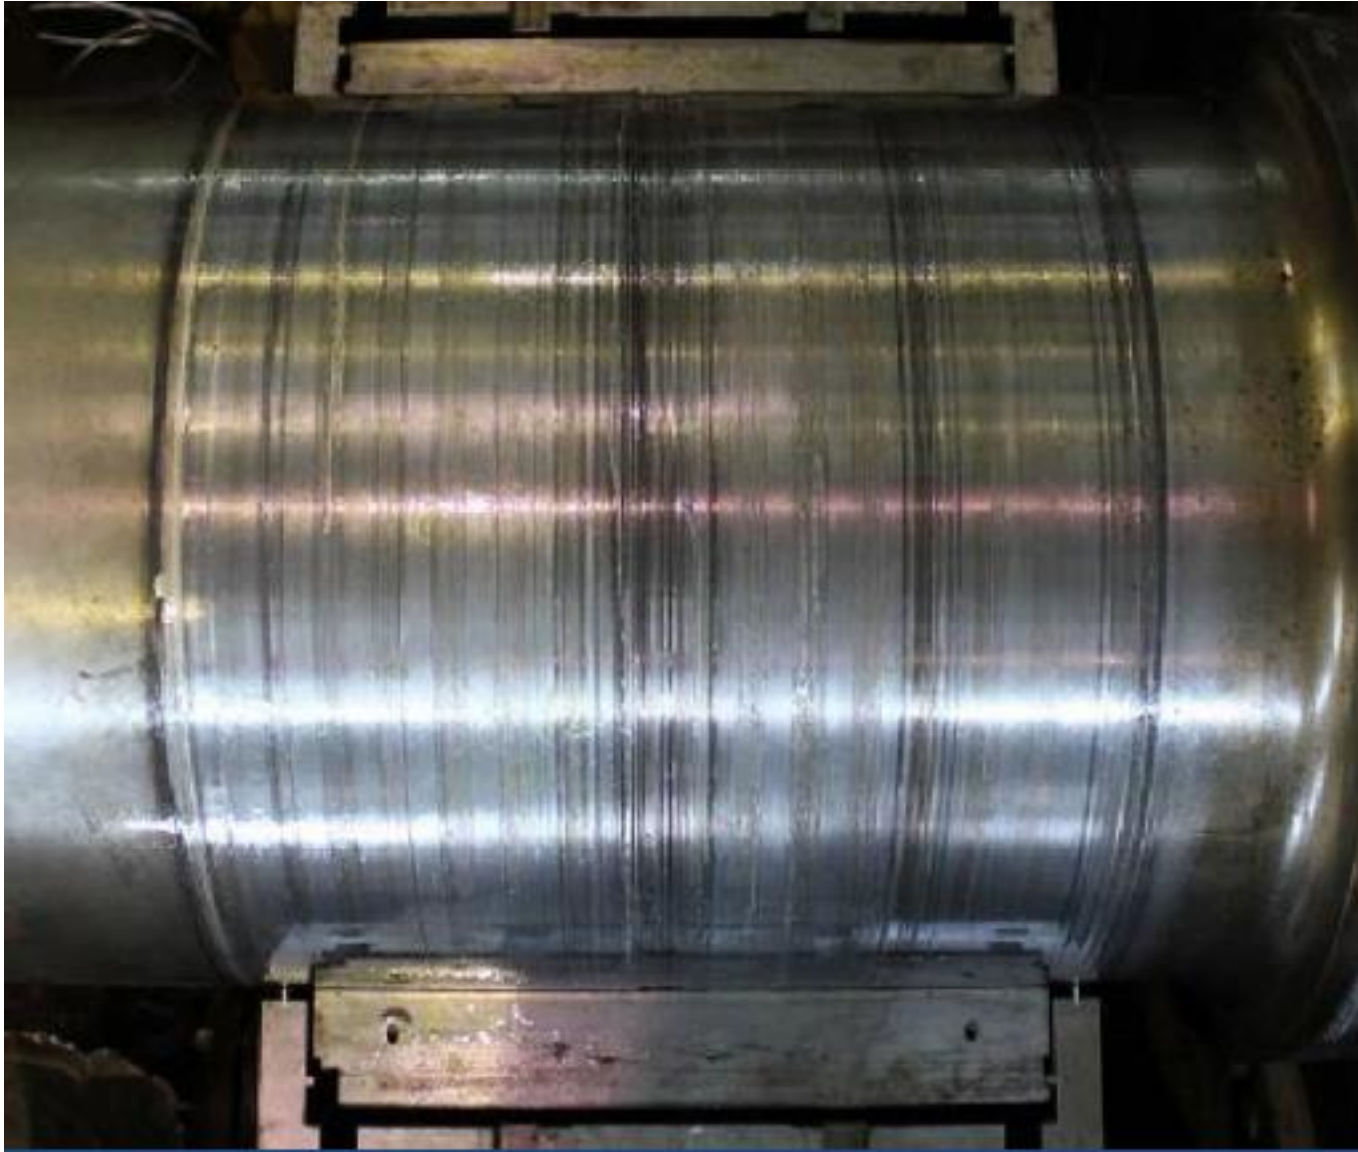
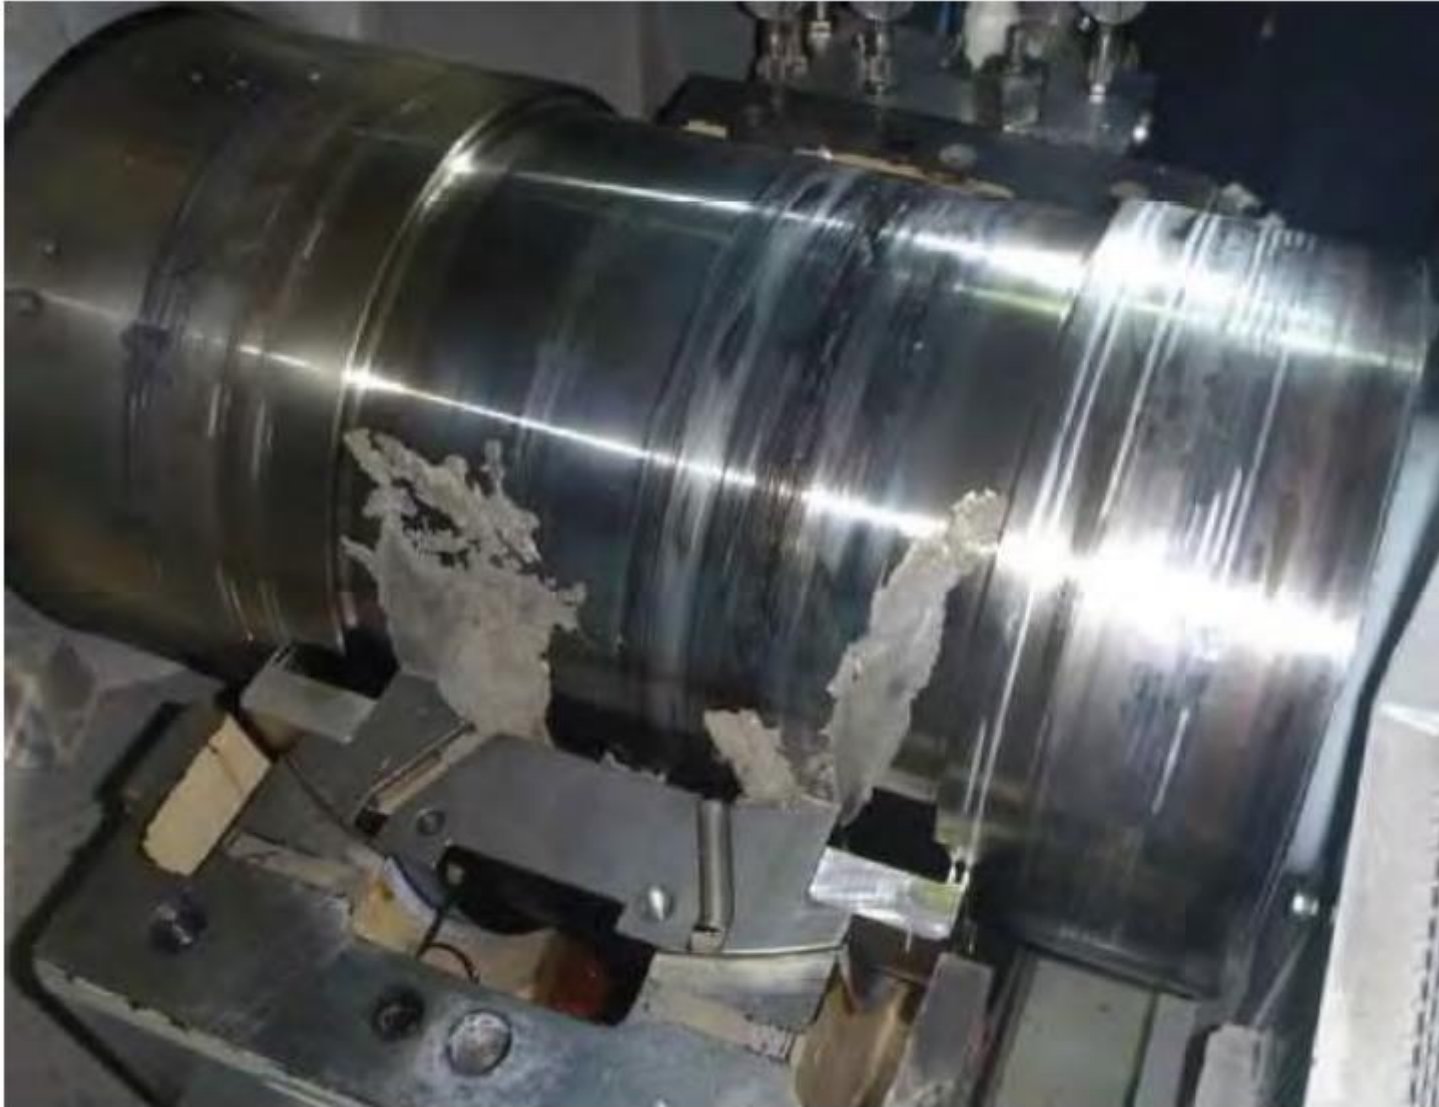
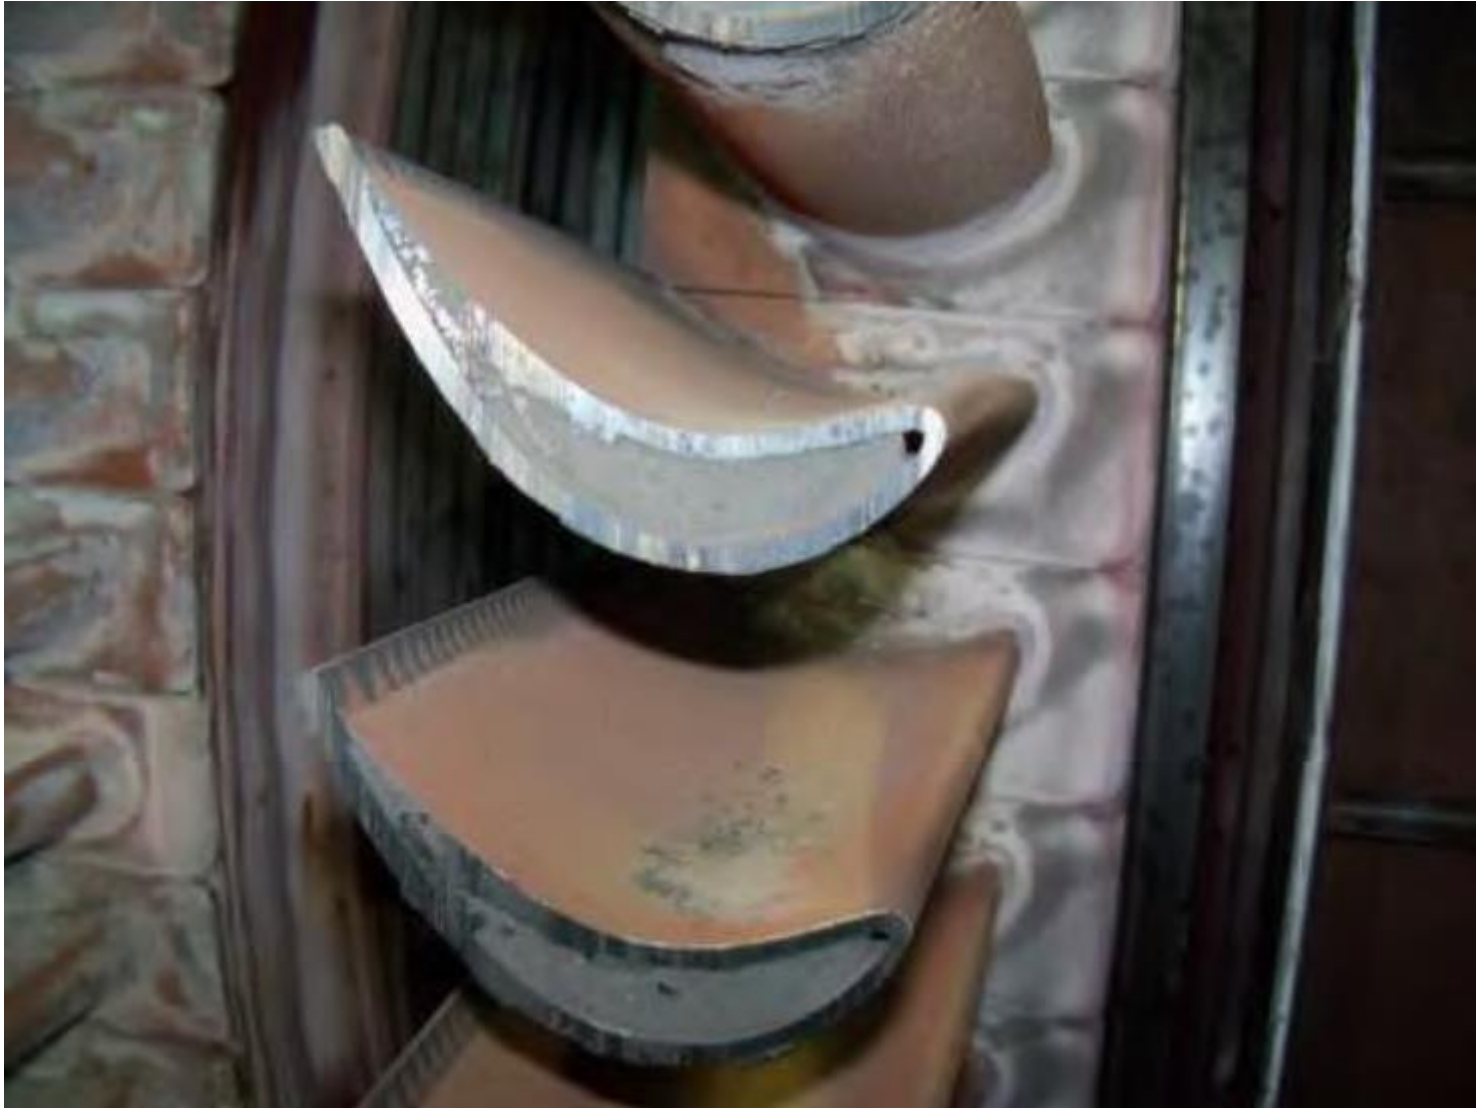
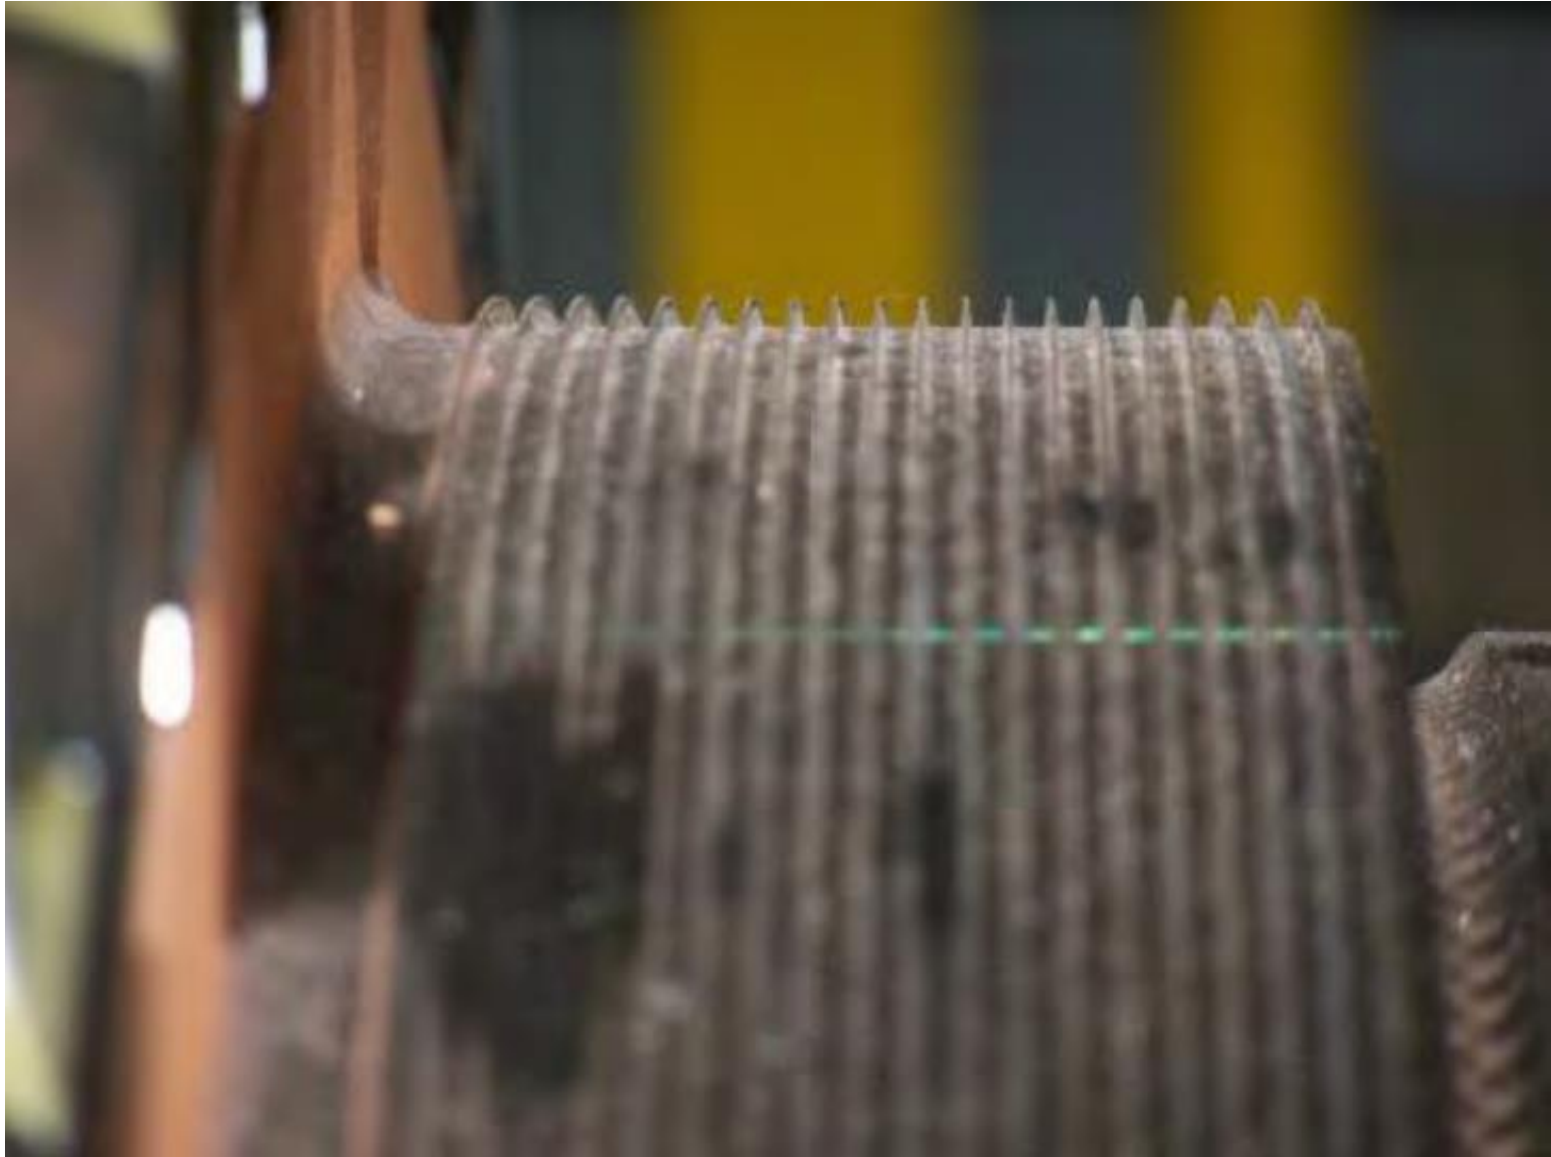
## TYPICAL ROTOR DAMAGE

- Plant trip resulting in loss of AC Power Supplies**
- Emergency DC Oil Pump Fails to Operate**
- Turbine runs down without Lubricating oil / Seal oil**
- Damage to bearings due to overheating**
- Damage to generator hydrogen seals**
- Potential lubricating oil fire and / or generator hydrogen explosion**
- Damage to turbine stationary parts seals and diaphragms, and to rotating blades due to contact**
- Overheating damage to turbine rotor**
- Seizure of shaft and potential for shaft bowing**
- Potential contamination of generator from metallic debris**

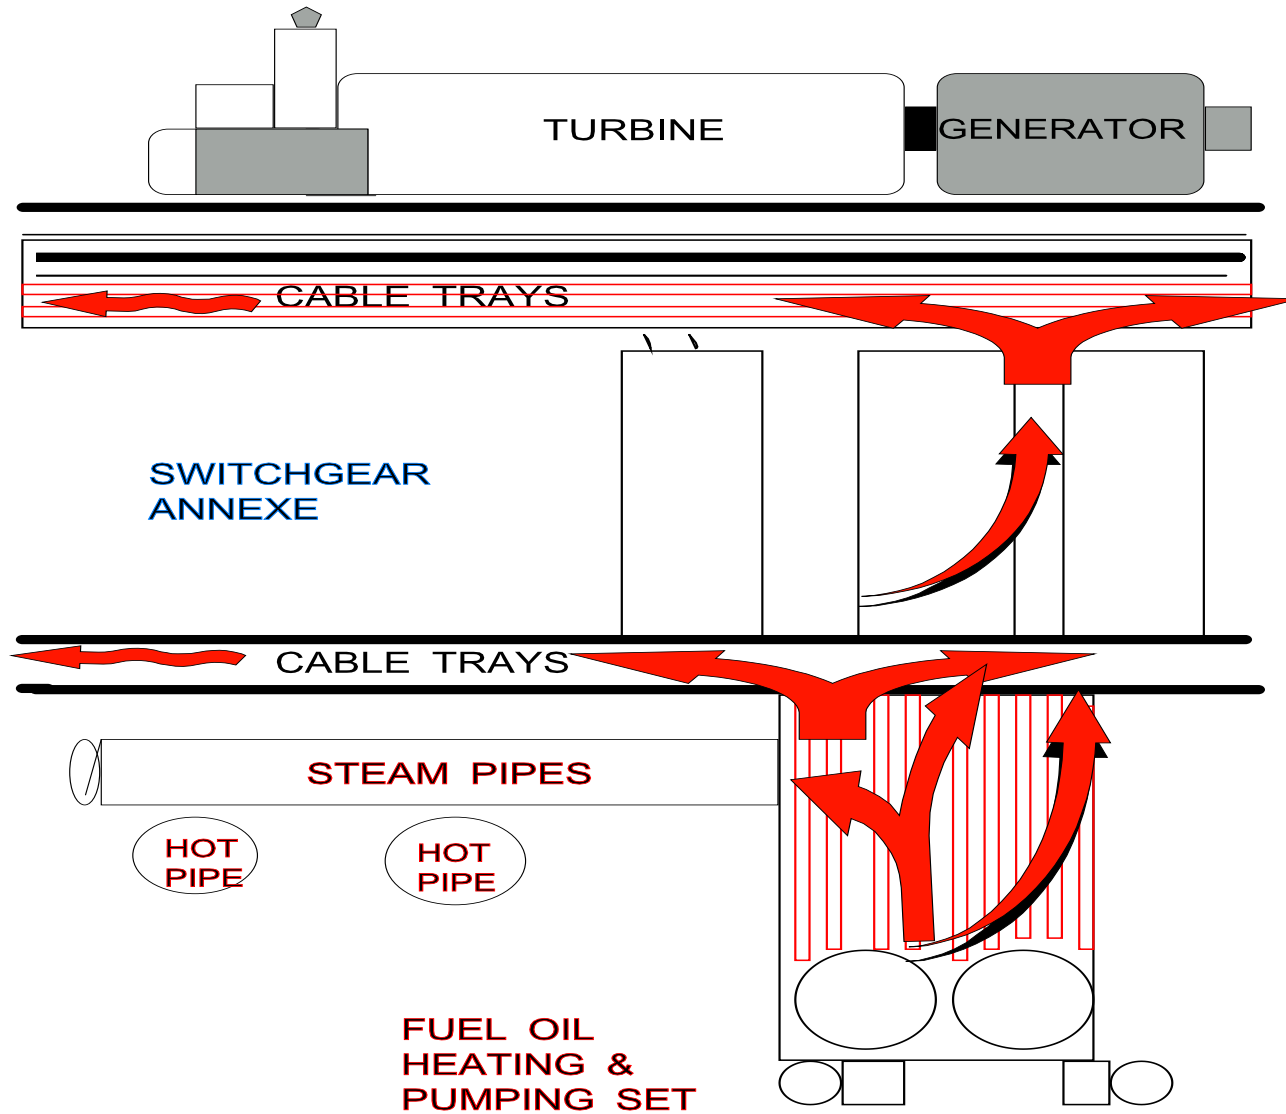
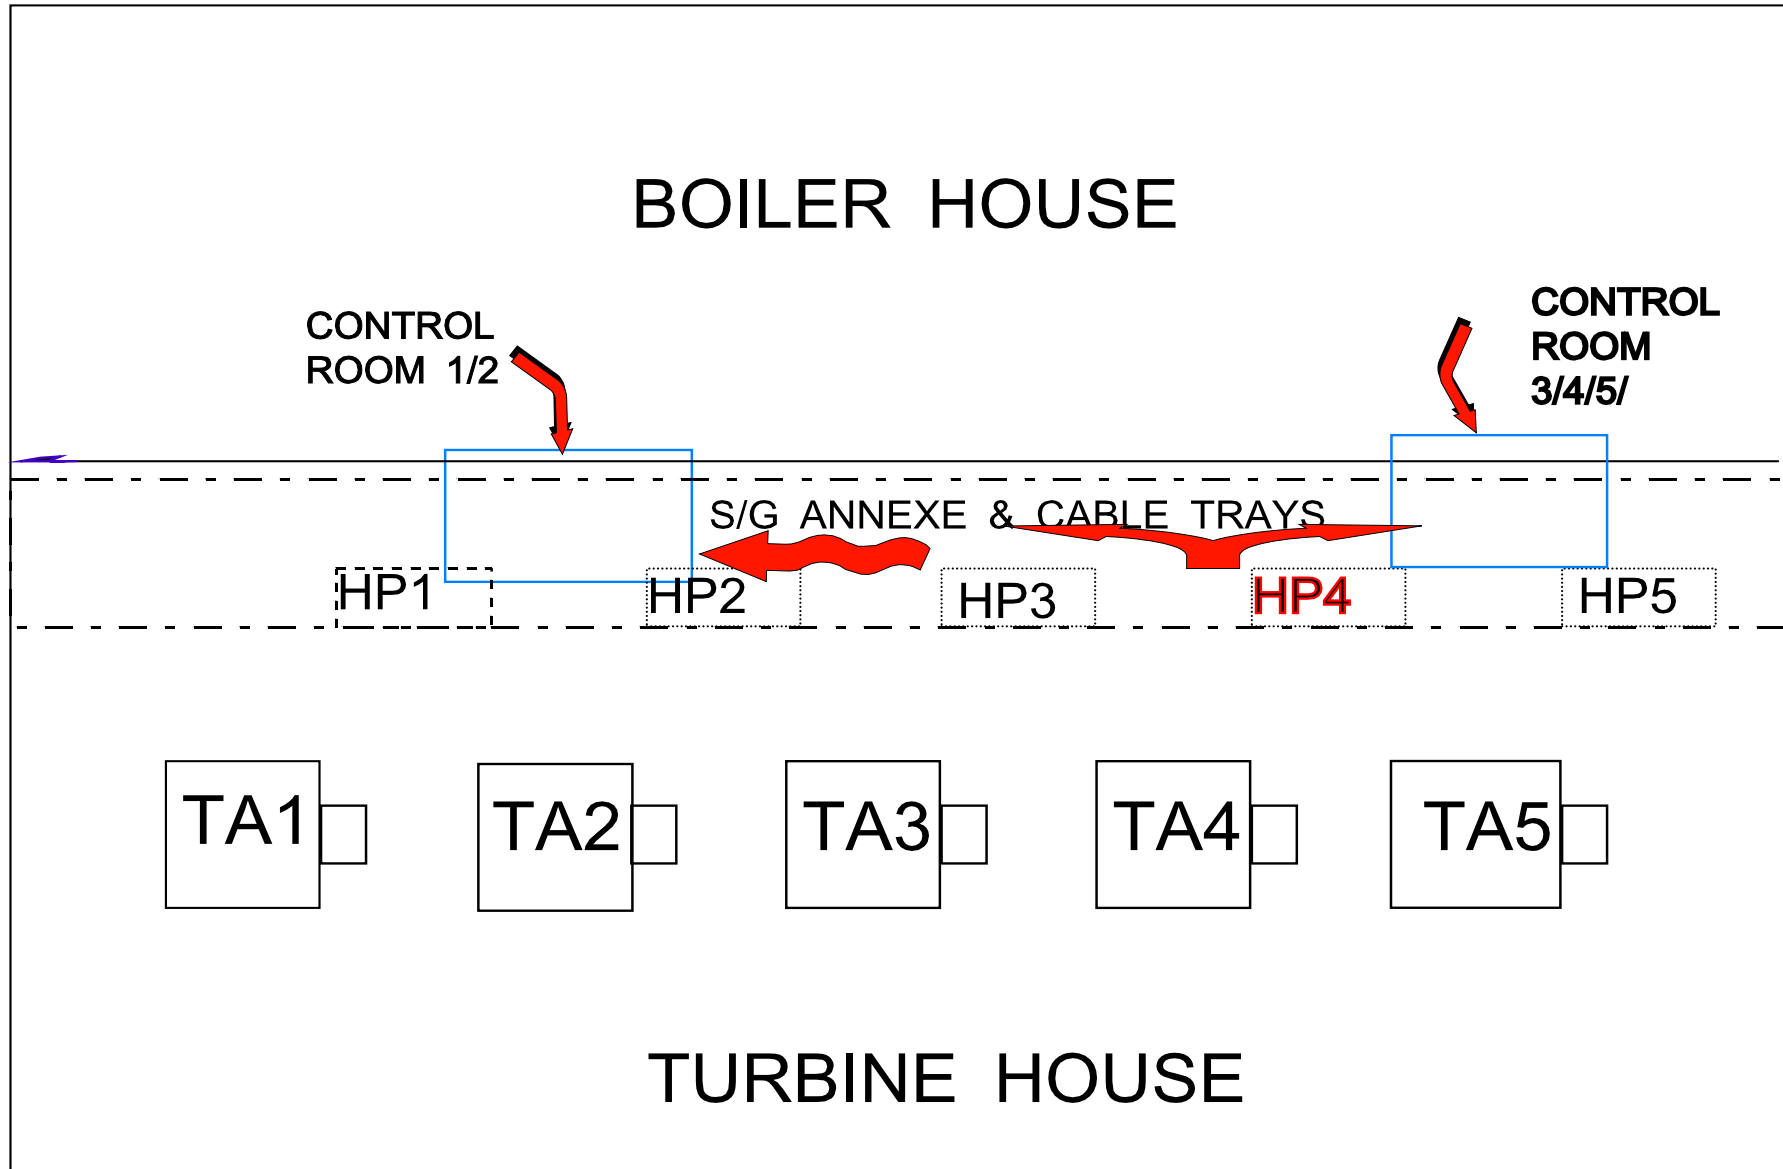
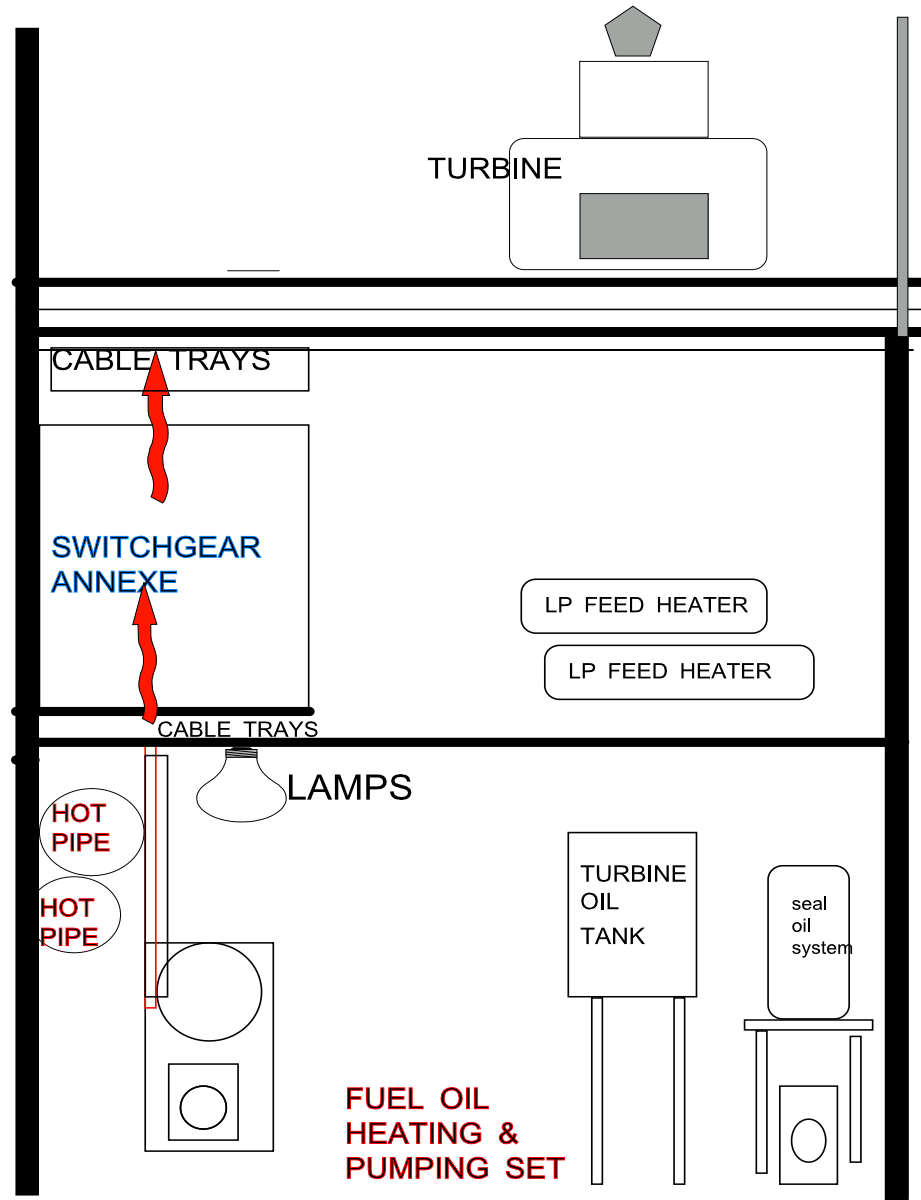
# LUBE OIL FIRE SPREAD

- Turbine house of a thermal power station
- 5 steam 70MW turbine-generator units, axially in line
- Enclosed turbine hall 315m long x 41m wide
- Each t-g unit has own aux plant within the footprint of the unit.
- Layout - ground floor
- Steam pipes cross the ground floor area, and penetrated the boiler-turbine house division wall near to the fuel oil heating and pumping sets
- Incandescent lamps light the area above the fuel oil pump set
- A small, pinhole sized leak in the hot oil discharge pipe of the heavy fuel oil heating and pumping set for unit number 4 occurred.
- Due to corrosion or poorly fitted pipe jointing material
- Fuel oil in this pipe is at 19 barg and 90C
- These conditions create an **oil mist** which is ignited by –
  - Hot unprotected steam pipes or
  - Unprotected incandescent lamps
- Resultant fire resembles a jet fire, ignites nearby vertical cable trays.

- Negative Loss Control Features
  - Location/Layout
    - Poor location of fuel oil heating and pumping unit - within the turbine house directly below cable runs close to hot steam pipes

- No segregation provided between units in switchgear/cable annexe
  - Design/Construction
    - Cables do not have a fire retarding or intumescent coating

- Poor choice of lamps in a potentially hazardous area - should be explosion proof rated
    - None of the cable trays fire blocked at penetrations through walls, floors and ceilings

- Design/Construction
    - Control cables not run in conduit or duplicated
    - No diversification of control cable routes - all units' control cables run on same cable tray

- No pipe penetrations were sealed
  - Management Systems
    - Inadequate surveillance of areas without fire detectors
    - Station fire team inadequate to fight fierce, well developed fire
