# CAN WE LEARN FROM PAST INCIDENTS

Paul Markham

London Power Forum, The Altitude, London, 13 Nov 2014

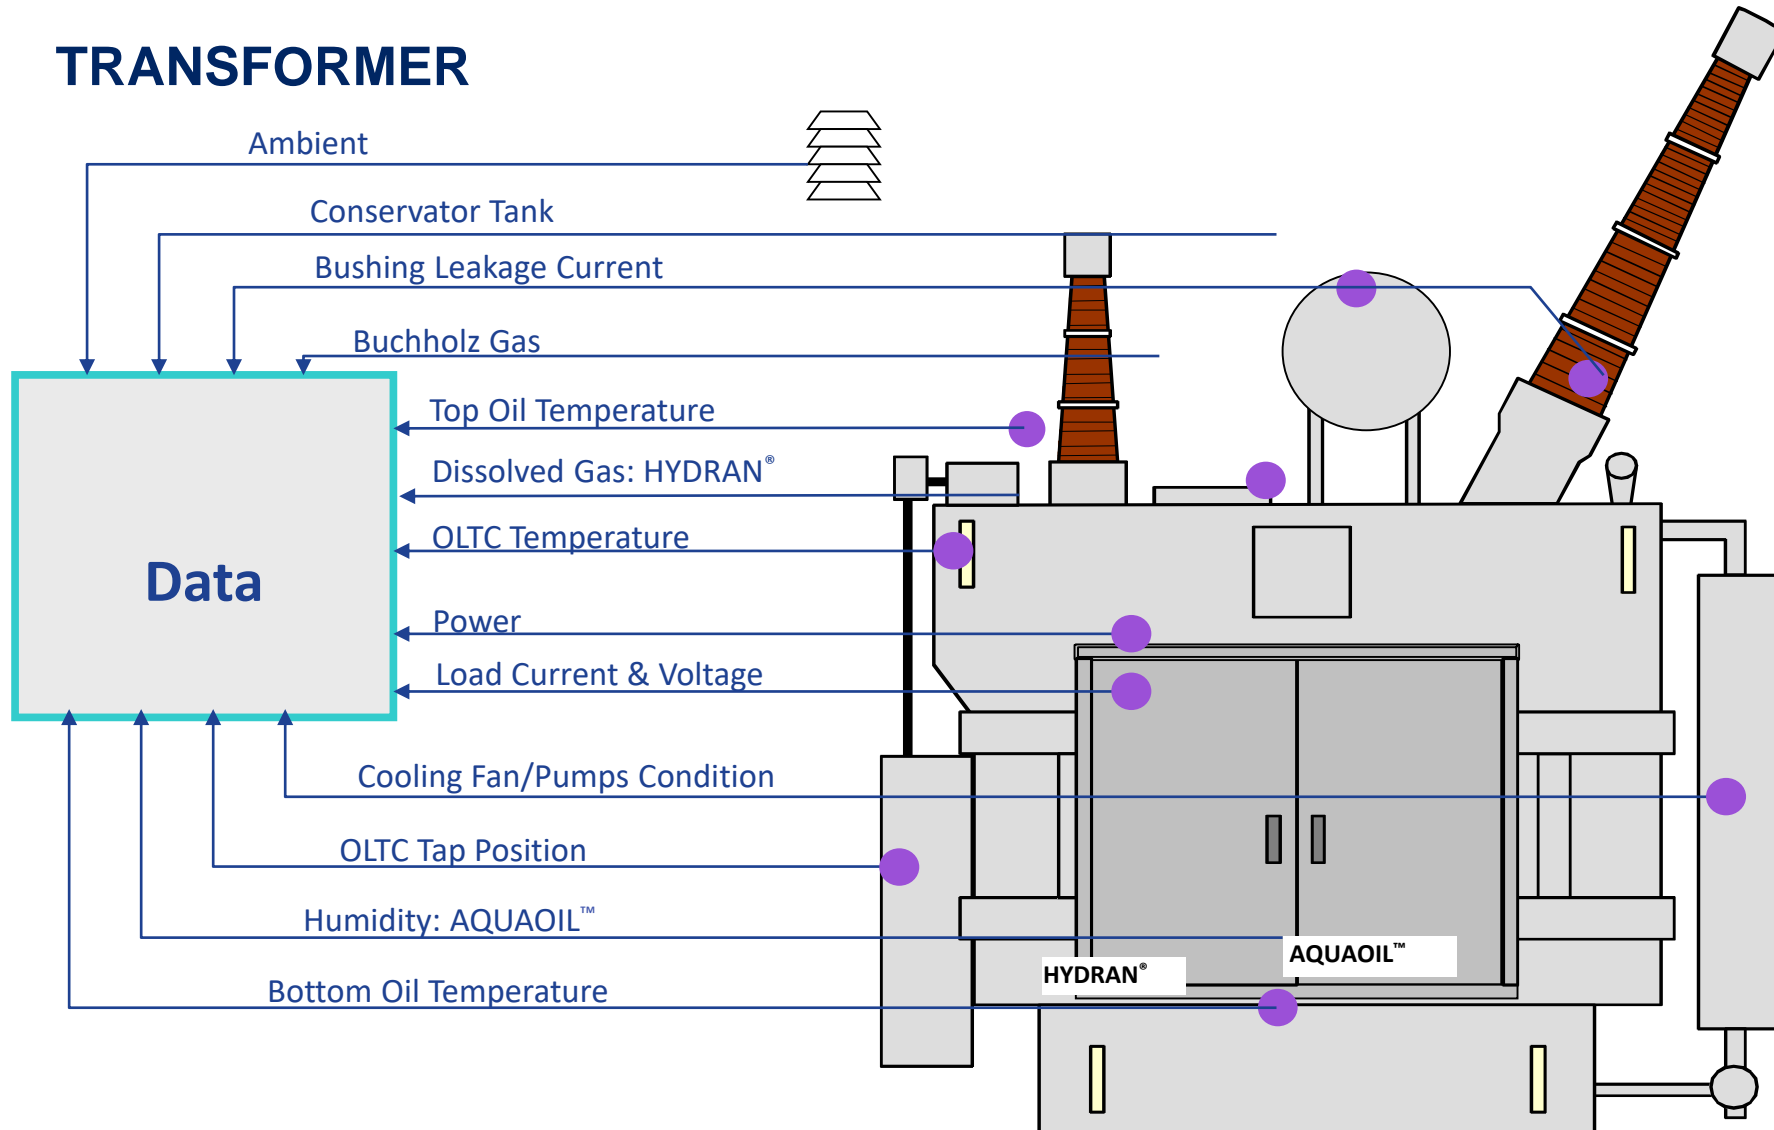
## TRANSFORMER

- About 2/3 of losses involving GSU transformers, typically more highly loaded and cyclic operation – industry statistics indicate 2% failure rate
- Majority of claims involve PD only as BI not covered, typical in USA
- Oldest transformer 1964 and youngest 2010, variety of manufacturers – no particular trend on age or manufacturer
- Main cause of loss from internal fault, often have latent defect which is exposed in future years when system fault condition occurs
- Evidence of poor plant behaviour - running transformer to destruction with no fleet replacement strategy
- Some clients use insurers as ‘spare parts supplier’
- Root cause often not identified, once policy coverage established

**CAN WE IMPROVE?**
